**YAMAHA**

# SERVICE NEWS

**TX81Z**

BULLETIN NO.: E-399

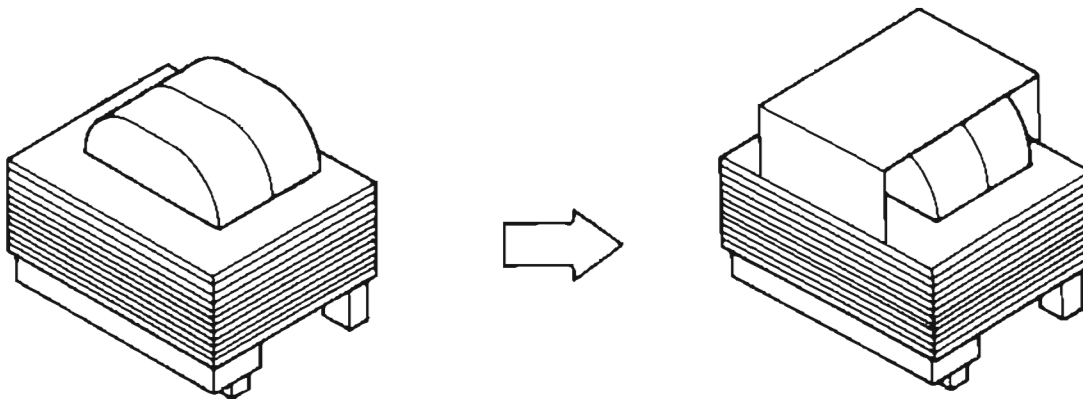
## Power Transformer Modified

**Modification:** A metal cover has been added to the transformer to prevent vibration due to leak magnetic flux.

Parts:	Description	Part No.	Remarks
	Power Transformer	XB358002	U, C
	Power Transformer	XB359002	H, D, A
